# NATIONAL RIFLE ASSOCIATION

## ACCIDENT AT UK MILITARY RANGE SPRING 2014

Redacted version for public release – redactions indicated by *italic text*

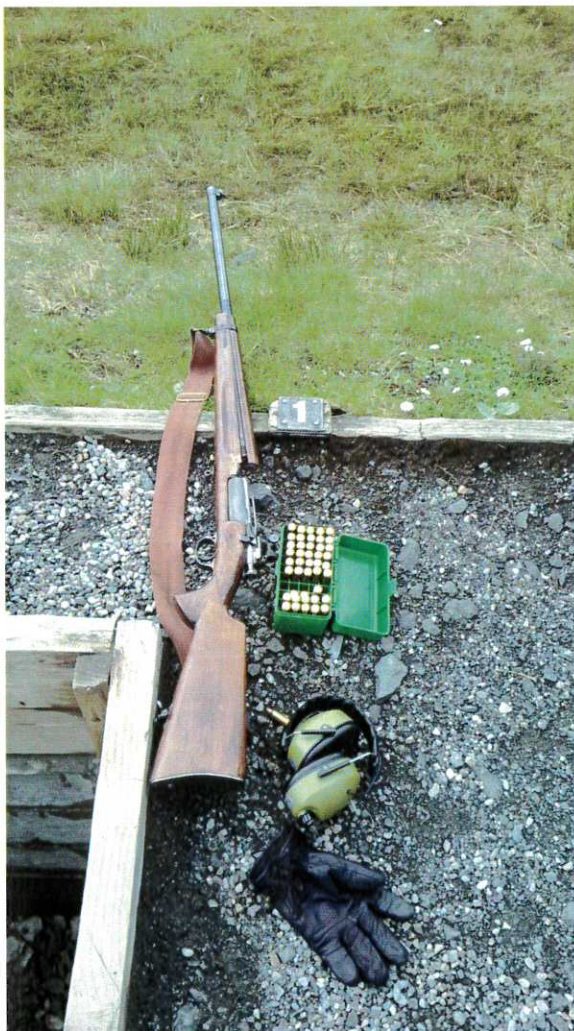
Photograph 2 – Krag-Jorgensen rifle, ammunition and accessories at No1 fire pit shortly after the accident.

5. The accident happened when *Mr D*, a member of *RCB*, was firing his Krag-Jorgensen rifle<sup>5</sup> from the standing position in the right-hand side of the No1 fire pit<sup>6</sup> using home loaded 6.5x55 ammunition.

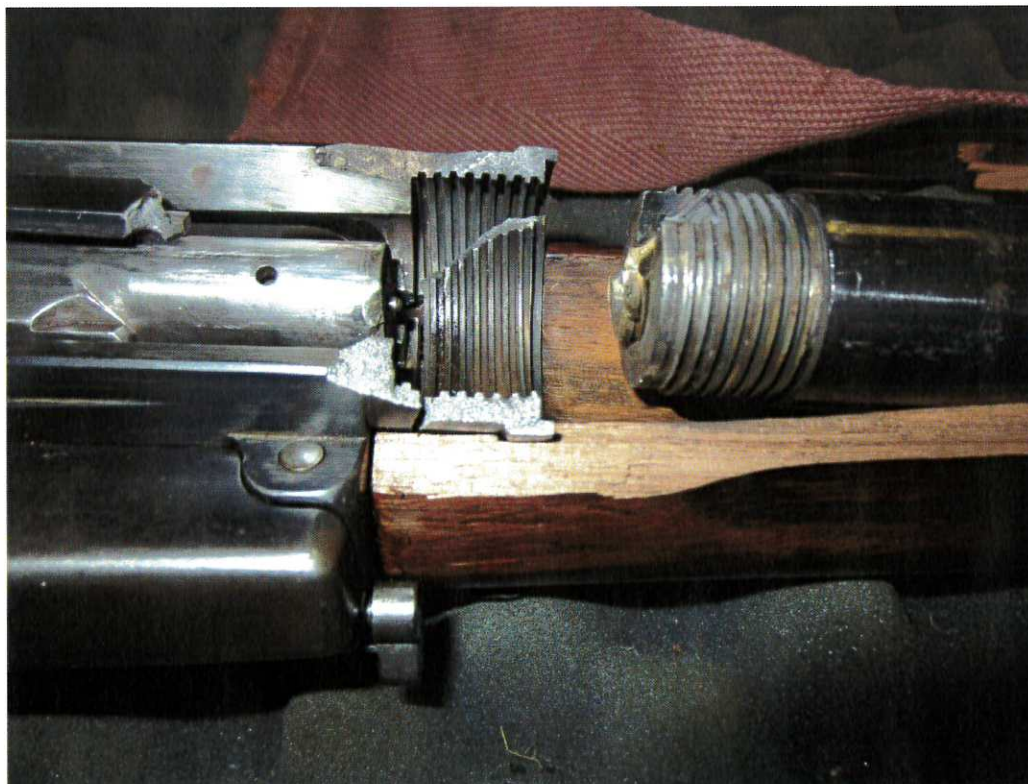
6. Accident Cause. The immediate cause of the accident was the rupture of the cartridge case on firing the fourth shot of a series, which released hot high pressure propellant gases into the rifle action, leading to catastrophic failure of the receiver forward ring<sup>7</sup>. The threaded portion of the receiver broke into at least 3 pieces and detached completely from the rest of the action, the extractor claw and a portion of the extractor arm detached, the entire left side of the action above the magazine access port distorted and failed at the rear of the magazine port. The barrel was driven forward several inches clear of the action, and the woodwork shattered around the receiver area. Metallic fragments and wood splinters were ejected at high speed in several directions<sup>8</sup>. Not all parts of the firearm have been recovered.

Photograph 4 – Krag-Jorgensen rifle after the accident. Two parts of the receiver ring in the centre of the photograph, broken end of the extractor upper left, barrel with ruptured case in the breech right.

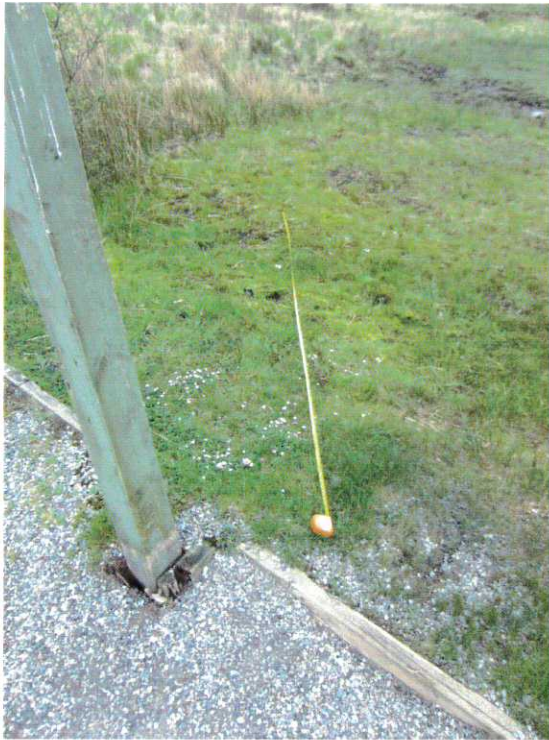
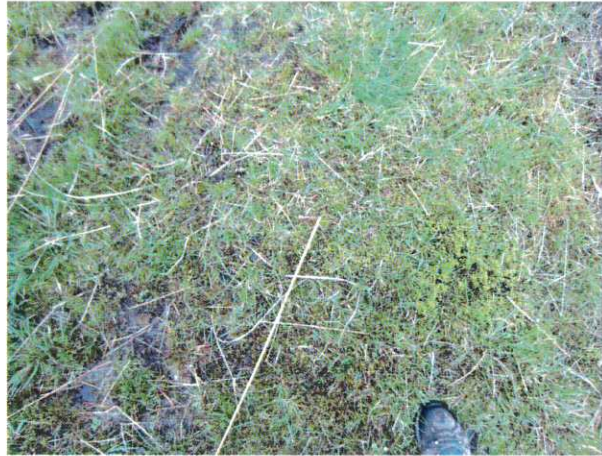
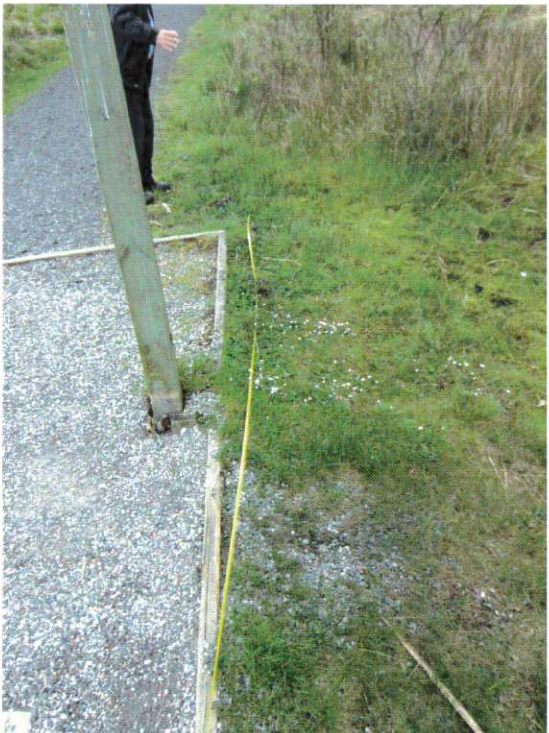
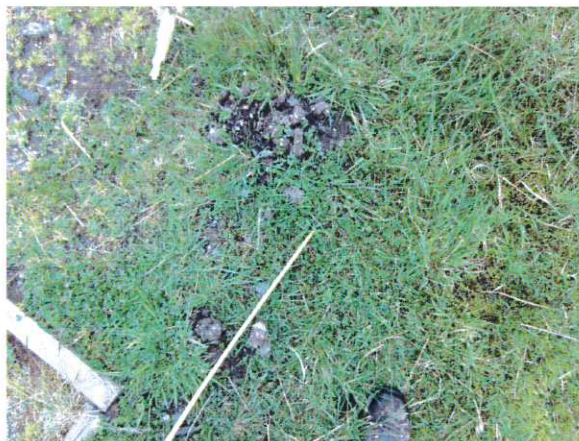
Photoset 5 – examples of fragments of wood from the stock located around No1 fire pit.

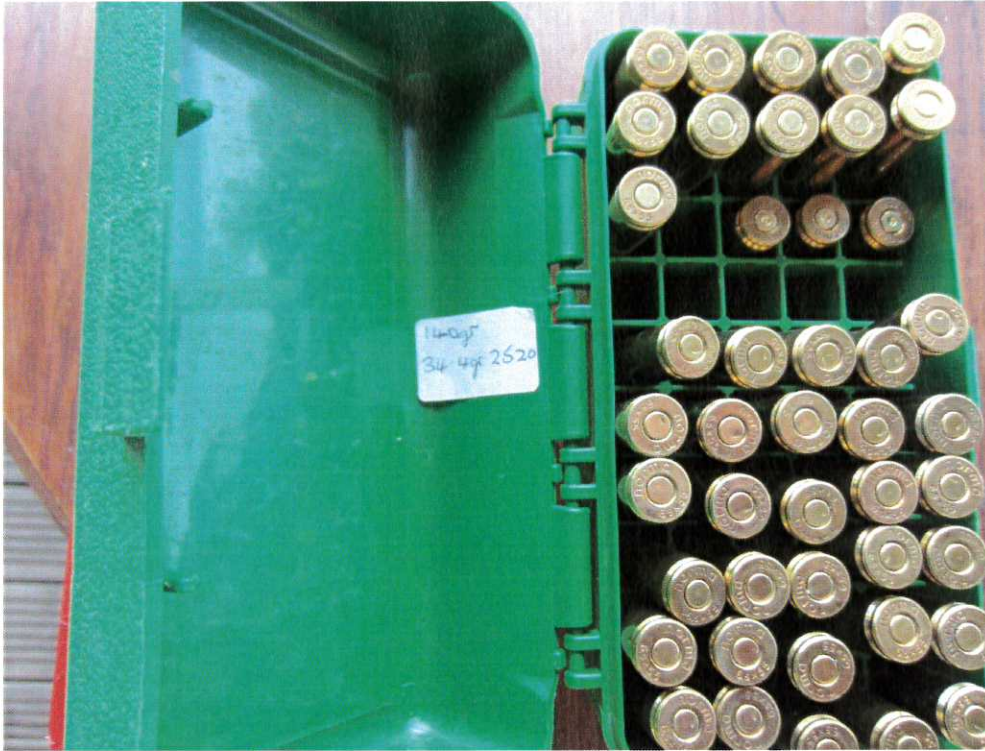
Note: The powder removed from 10 cartridges weighed 340.6gr and had a volume of 22ml<sup>11</sup>. Useful case capacity for a 6.5x55 case is quoted as 3.68 ml<sup>12</sup>, thus the mean proportion of case volume taken by the propellant in the 10 cases dismantled was 0.60. It has been observed<sup>13</sup> that too little powder of a slow burning variety can in rare cases cause excessive pressure. The powder used in this accident is noted by *D*, in the lid of the ammunition box<sup>14</sup>, to be Accurate 2520, which is a relatively slow burning rifle powder. The powder removed is consistent in appearance with a sample of Accurate 2520. *D* includes in his written submission<sup>15</sup> that the powder is Lovex D073.6. As retailers of powder, the NRA is aware that the Lovex product and the Accurate product are the same powder, and both designations appear on the retail container. The mechanism by which excess pressure might arise from a reduced charge is not technically understood. One of the conditions quoted is that the reduced charge must be 25% to 35% under normal. Since a normal load is typically about 80% of case volume, the mean load provided here ( $60/80 = .75$ ) is on the limit that writers suggest is necessary for this condition to be of significance. Given that is a mean, it is likely that about half the loads were smaller than the mean, taking the volumetric proportion into the critical range.

Photograph 6 – ammunition box showing live rounds and fired cases recovered after the accident, and label indicating the bullet weight and powder load.

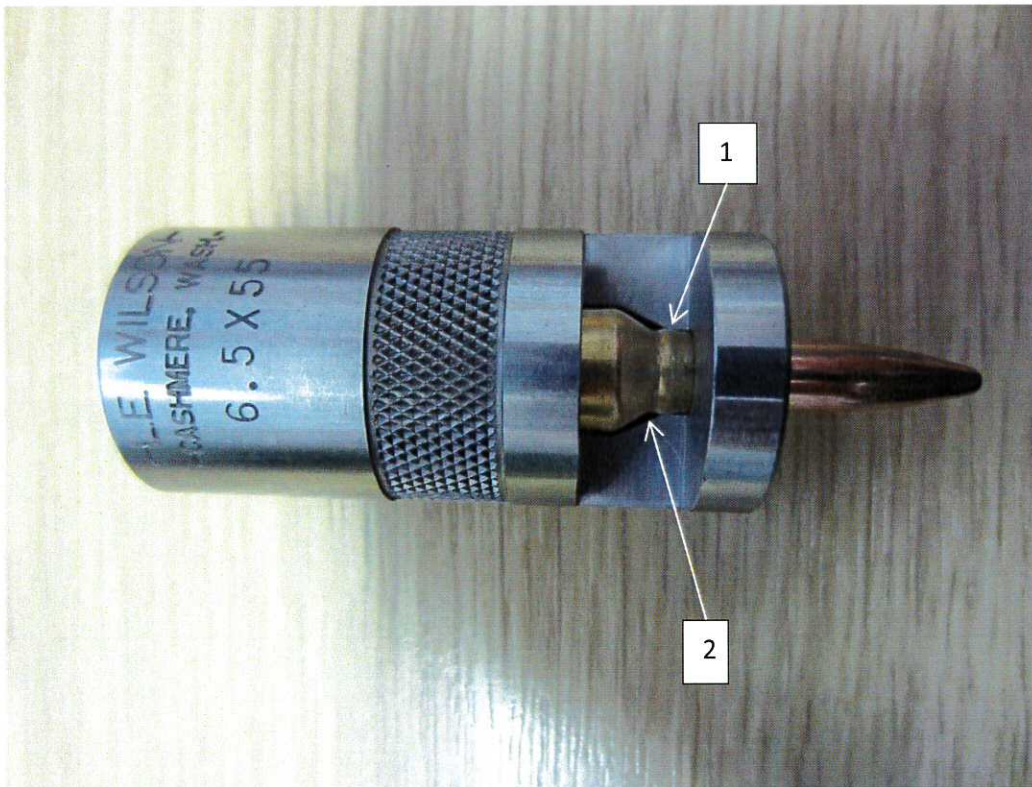
- c. Several cartridges have grossly deformed necks and/or shoulders.

Note: The deformations, at least one of which is clearly visible by eye<sup>16</sup> are indicative of improper setting or operation of the equipment at one or more stages of the reloading process.  
*Detail redacted*

Photograph 7 – Round of ammunition from ammunition box, inserted in a case gauge, which mimics the shape of the rifle chamber. Note the bulge in the neck of the case (1) preventing the shoulder of the case (2) from contacting the gauge.

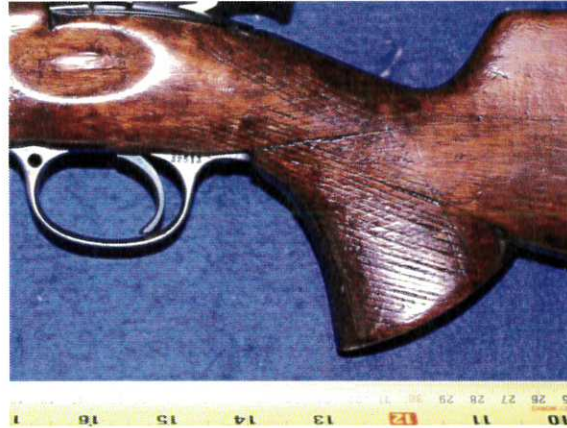
coloured varnished finish appeared hand applied and chequering on the semi-pistol grip and the underside of the forestock were crude. Furthermore, it appeared that the pistol grip and comb may have been replaced at some time due to the joins in the wood being visibly coarse, as shown in Figure 2.

**Figure 2 – Pistol grip and stock showing possible alteration marks**

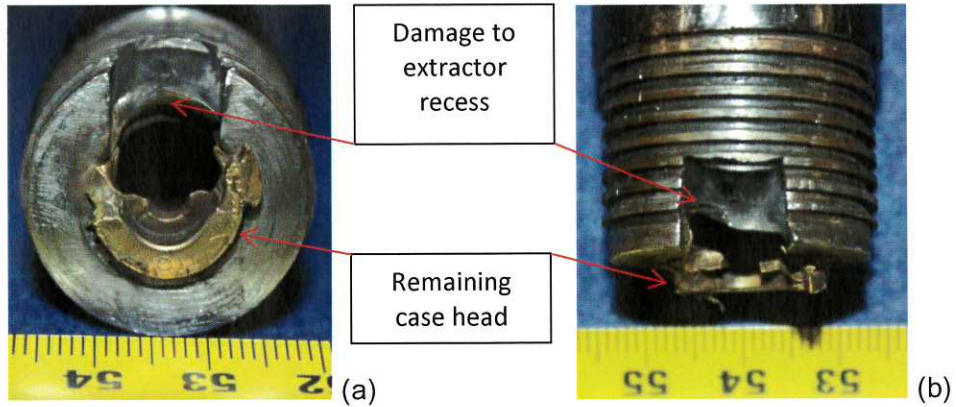
- 13) However, a ruptured cartridge case was still present within the chamber. The upper portion of the case head and primer cup were missing, with the remaining portion of the head exhibiting extensive plastic deformation resulting in almost complete separation from the case body. The remaining section of the head was protruding rearward out of the chamber. The chamfered recess at the top of the barrel to accommodate the extractor claw was also visibly deformed, particularly on the left side, as shown in Figure 3a and 3b.

**Figure 3 – (a) Ruptured cartridge case head, and (b) deformation to extractor recess**

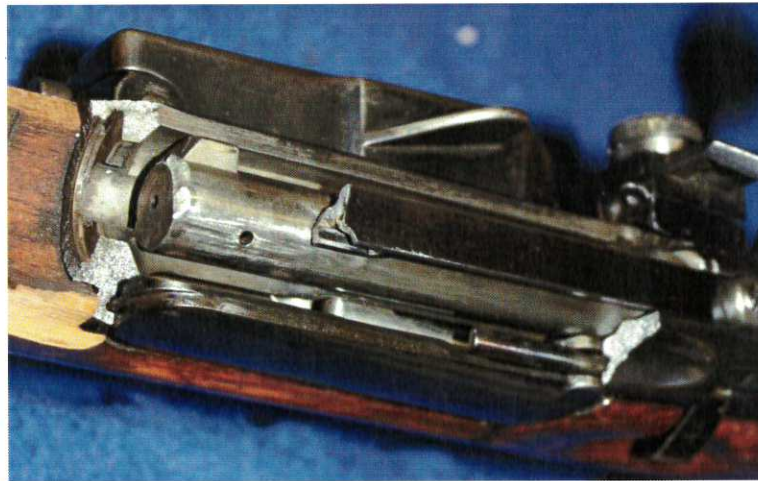
14) The front portion of the receiver had suffered extensive damage resulting in the separation of the receiver ring and the left side of the receiver from the receiver body, as shown in Figure 4. The left side piece and the lower portion of the receiver ring were present, shown in Figure 5 (a) and (b), respectively; however, the upper / right sections of the receiver ring were missing.

**Figure 4 – Failed receiver**

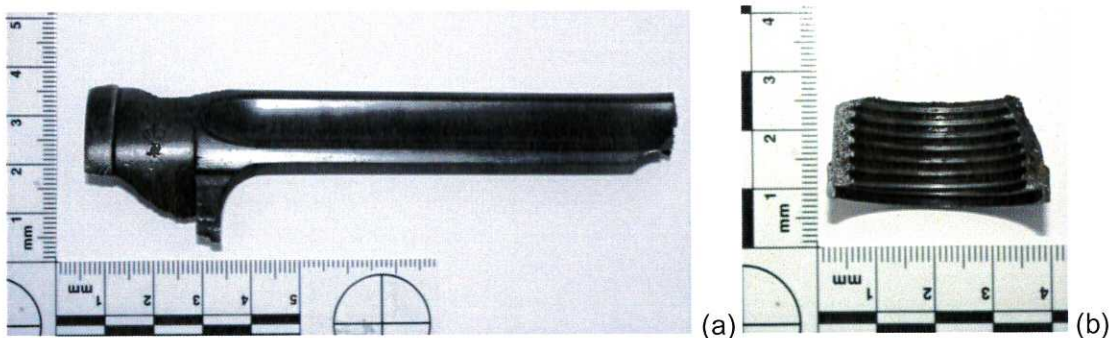
**Figure 5 – (a) Left side of receiver/receiver ring, and (b) lower part of receiver ring**

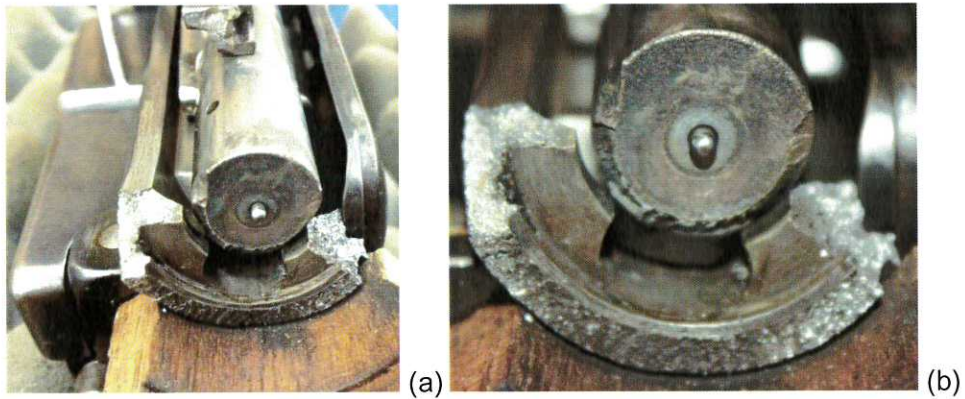
15) Furthermore, the front portion of the extractor was missing, shown in both Figure 4 and Figure 6 (a), with a fracture surface visible approximately 25 mm back from the bolt

face. Damage was also present along the edge the bolt face that appeared to be the result of the complete shearing away of the cartridge head control rib, shown in Figure 6 (b). Accompanying this damage was discolouration of the fracture surfaces on the bolt face and lower part of the receiver, and apparent soot deposits along the upper part of the bolt body.

**Figure 6 - (a) Fracture surfaces of the front section of the receiver, and (b) fracture surfaces on the bolt face edge (note the discolouration on the bolt and the bolt face).**

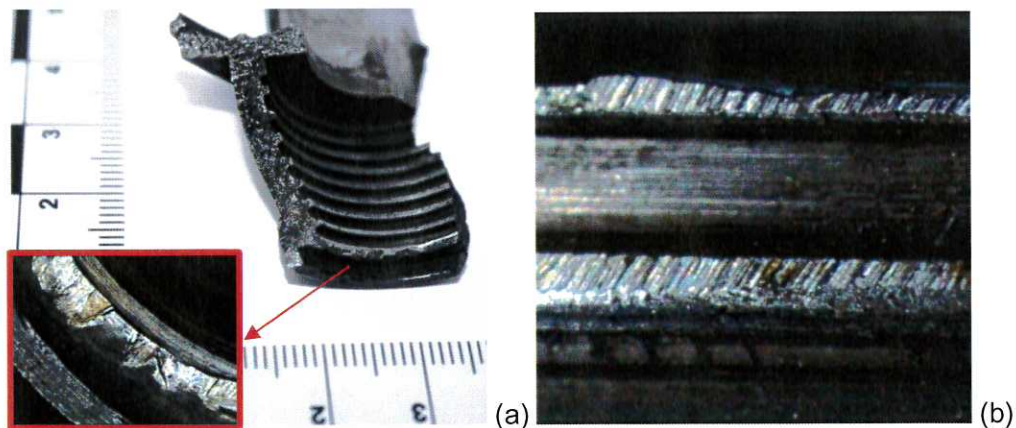
- e. Macroscopic examination of the front face of the left side of the receiver ring showed strike marks visible on the first screw thread, as shown in Figure 7(a). These marks extended onto the top surface of the second thread producing coherent striations, as shown in Figure 7(b). These strike marks appeared to have been created by a flat faced object with straight sides, such as a screw driver tip or punch, and due to the coherence of the striations between screw threads they could not have been deposited when a barrel was fitted into the receiver ring<sup>24</sup>.

16) Macroscopic examination of the front face of the left side of the receiver ring showed strike marks visible on the first screw thread, as shown in Figure 7(a). These marks extended onto the top surface of the second thread producing coherent striations, as shown in Figure 7(b). These strike marks appeared to have been created by a flat faced object with straight sides, such as a screw driver tip or punch, and due to the coherence of the striations between screw threads they could not have been deposited when a barrel was fitted into the receiver ring.

**Figure 7 – (a) Strike marks on front surface of screw thread, and (b) concurrent striations on thread surfaces**

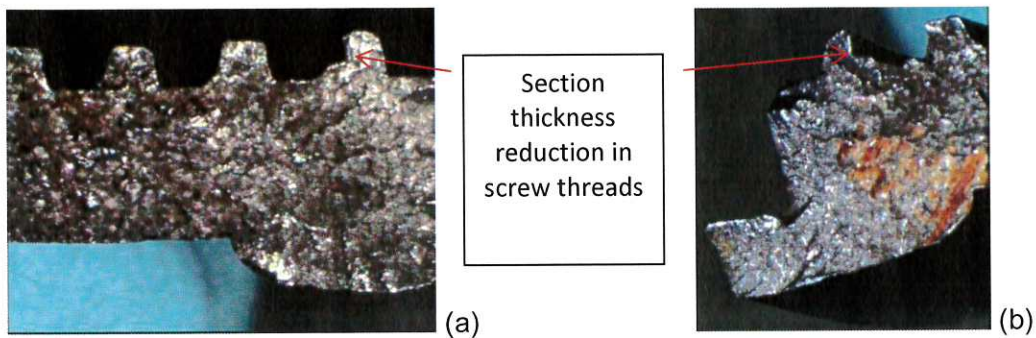
**Figure 8 – Cross section view of first screw threads from (a) left side of receiver ring, and (b) lower receiver ring.**

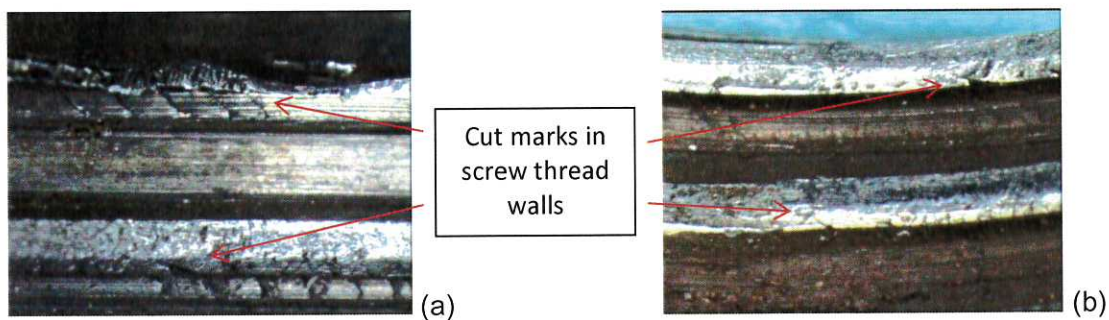
- f. Closer inspection of the screw threads on the receiver ring sections indicate that the first thread from the front to have been partially removed at some time, reducing its thickness by approximately half, as shown in Figure 8. Furthermore, numerous cut marks were visible on subsequent thread walls, which may have been as a result of attempts to alter the thread width or depth, shown in Figure 9<sup>25</sup>.

17) Closer inspection of the screw threads on the receiver ring sections indicate that the first thread from the front to have been partially removed at some time, reducing its thickness by approximately half, as shown in Figure 8. Furthermore, numerous cut marks were visible on subsequent thread walls, which may have been as a result of attempts to alter the thread width or depth, shown in Figure 9.

**Figure 9 – Cuts in screw thread walls on (a) left side of receiver ring, and (b) lower receiver ring.**

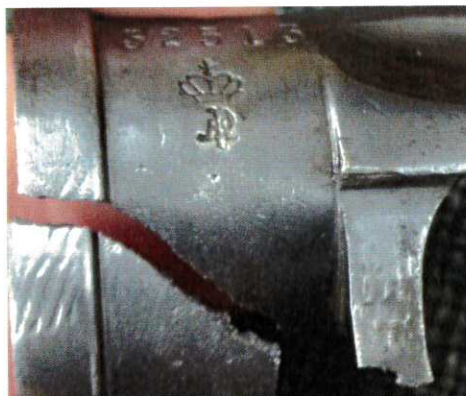
- g. ...on the exterior surface of the left side and lower receiver ring sections were a series of uniform impressed marks, as shown in Figure 10. These marks may have been the result of this area being struck by another object or due to compression by another surface, such as being clamped in a vice or similar holding device. The presence of these marks may indicate that alterations have been performed on the rifle action at some time and the work may have been undertaken by an inexperienced or amateur gunsmith<sup>26</sup>.

18) Furthermore, on the exterior surface of the left side and lower receiver ring sections were a series of uniform impressed marks, as shown in Figure 10. These marks may have been the result of this area being struck by another object or due to compression by another surface, such as being clamped in a vice or similar holding device.

**Figure 10 – Impressed marks on exterior of receiver ring**

19) The presence of these marks may indicate that alterations have been performed on the rifle action at some time and the work may have been undertaken by an inexperienced or amateur gunsmith.

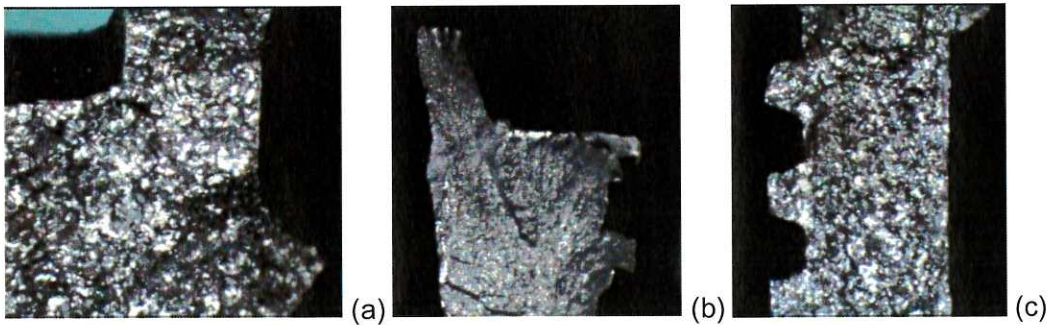
21) Microscopic examination of the fracture surfaces showed a faceted surface topography associated with trans-granular cleavage, as shown in Figure 11. Although commonly associated with brittle fracture, this type of failure occurs in many types of metal, including many steels, when deformed at very high strain rates. All of the fracture surfaces examined exhibited this type of fracture surface.

**Figure 11 – Fracture surfaces of (a) lower surface and (b) upper surface of the left side of the receiver, and (c) the right side of the lower section of the receiver ring**

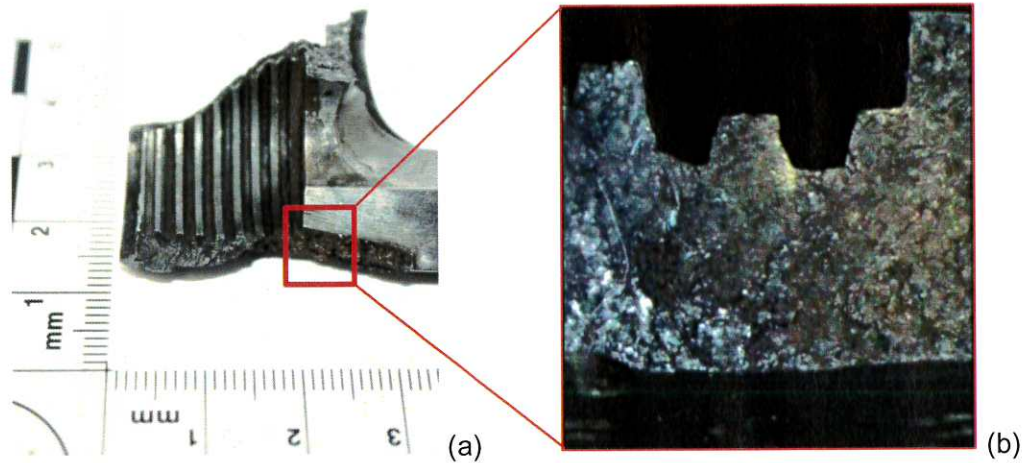
23) During the examination of the fracture surfaces two areas were selected for detailed examination. The first area, as previously mentioned, was the fracture surface between the lower section of the receiver ring and the receiver body. These surfaces were discoloured (see Figure 6) when compared to the bright fracture surfaces present on most other parts examined. However, on microscopic examination no obvious crack initiation site(s) were observed. A second discoloured area was observed along the upper section of the left side of the receiver, as shown in Figure 12. It can be seen that along with a darkening of the fracture surface, a brass coloured mark was also observed adjacent to a screw thread located toward the rear portion of the receiver ring.

**Figure 12 – (a) Upper fracture surface of the left side of the receiver, and (b) close-up showing the brass-coloured discoloration**

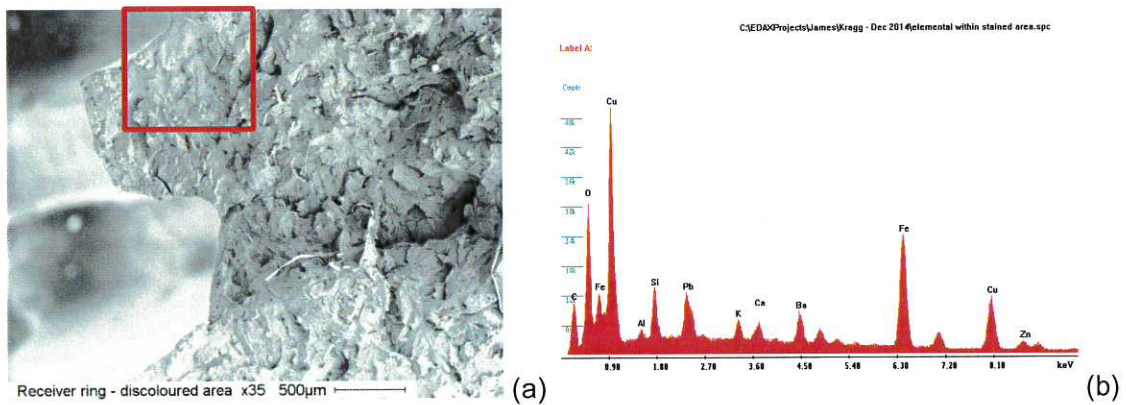
24) SEM and elemental analysis was conducted in this area, as shown in Figure 13. The cleavage fracture surface can be clearly seen and the elemental analysis shows the presence of copper and zinc, as well as lead, barium, silicon, potassium, calcium and aluminium. The source of the copper and zinc could be the cartridge case alloy and the lead, barium, silicon, calcium and aluminium could have come from the primer compound i.e. elements present in the primer have condensed onto the fracture surface, although the exact primer formulation used was unknown.

**Figure 13 – (a) SEM image of discoloured fracture surface, and (b) corresponding elemental composition**

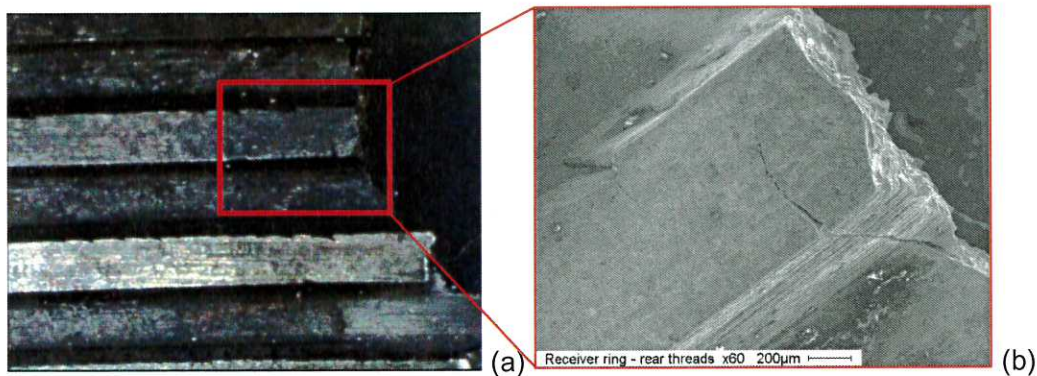
- j. It was observed that cuts were present in the walls of the screw threads in the receiver ring. It cannot be excluded that one or more of these could have acted as a crack initiation site, as demonstrated by the presence of a secondary crack emanating from one of these cuts on the left side of the receiver ring<sup>29</sup>.

25) Detailed examination of this area also revealed secondary cracking of the screw threads immediately below the fracture surface, as shown in Figure 14. It can also be seen that the smaller of the cracks appears to be emanating from a notch cut into the wall of the thread. Other notches in the walls of the screw threads were seen across the threaded parts but no other cracks were observed.

**Figure 14 – (a) optical image of cracks in the screw threads, (b) SEM image of the same area**

- 31) It was observed that cuts were present in the walls of the screw threads in the receiver ring. It cannot be excluded that one or more of these could have acted as a crack initiation site, as demonstrated by the presence of a secondary crack emanating from one of these cuts on the left side of the receiver ring (see Figure 14).

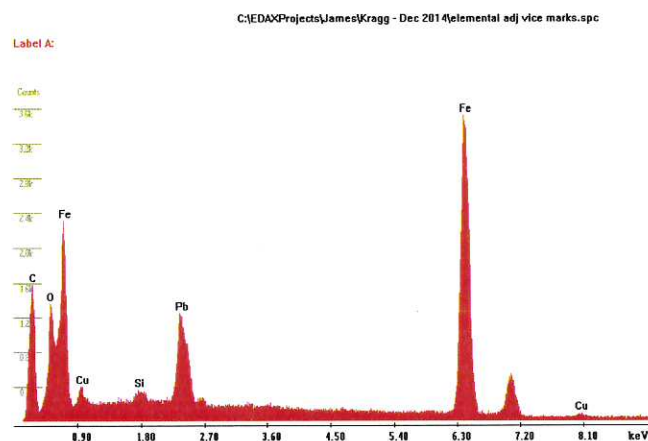
26) Chemical analysis of the fracture surfaces toward the front of the receiver ring showed a different composition, with lead present as the primary contaminant, as shown in Figure 15. This is likely to have originated from vaporisation of lead from the bullet base as well as lead residues present in the barrel bore from previous firings.

**Figure 15 – Chemical composition of fracture surface at the front of the receiver ring.**

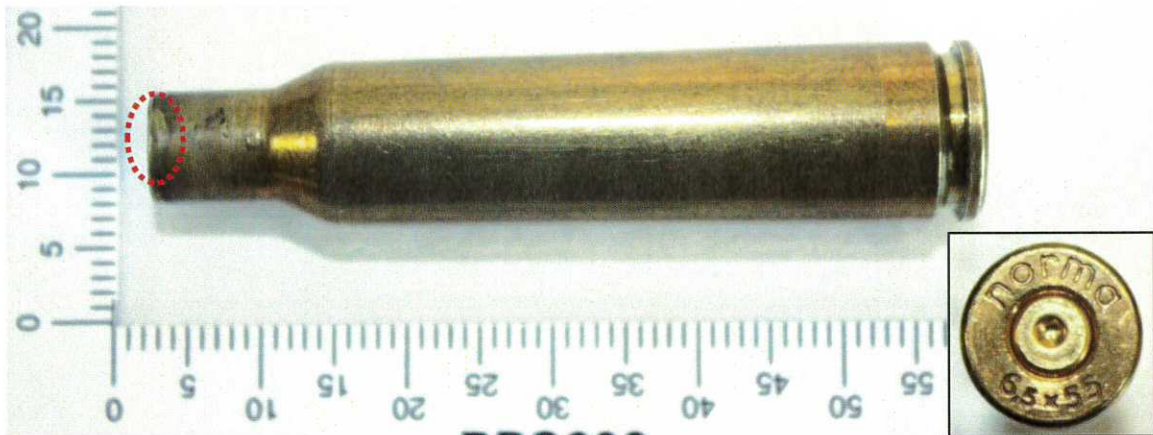
28) A fired 6.5x55 mm Norma cartridge case was also submitted, shown in Figure 16. Nothing remarkable was observed about the case, with no signs of bulging or excessive stretching along the case walls or around the base. The primer cup was not protruding

from the pocket and showed no signs of excessive flow. This indicated that there were no obvious headspace issues at the time this cartridge was fired. The only unusual feature was a small area of deformation on one side of the case mouth (circled), causing the mouth rim to appear slightly undulated.

**Figure 16 – Norma 6.5x55 mm fired cartridge case (insert: headstamp)**
