# NATIONAL RIFLE ASSOCIATION

## ACCIDENT AT UK MILITARY RANGE SPRING 2014

Redacted version for public release – redactions indicated by *italic text*

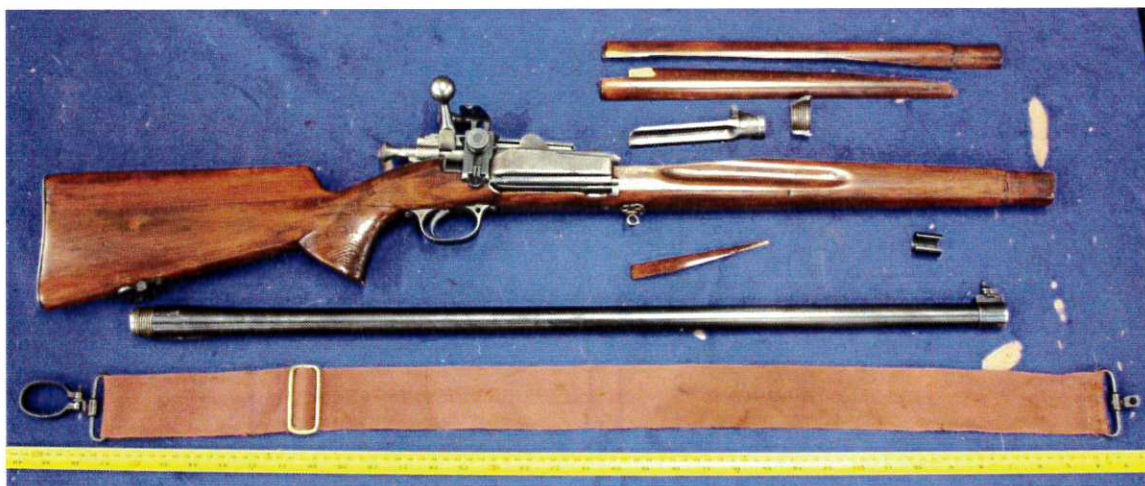
**Figure 1 – Submitted components of a Krag-Jorgensen rifle**

- 2) The component parts of a Krag-Jorgensen bolt action rifle were present inside a padded gun slip. The parts present are shown in Figure 1 and included:
  - A brown-colour varnished wooden stock with the major parts of the action still attached;
  - A heavy match-grade barrel, threaded at the breech end;
  - The lower section of the receiver ring;
  - The left side of the receiver ring and receiver body;
  - The fore sight hood;
  - Carrying strap with rear barrel band and swivel attached;
  - Three sections of brown-colour varnished wood from the hand guard and fore stock.

- 3) Apart from the damage associated with the catastrophic failure (discussed in detail in the following sections), the action, barrel and stock were in good condition and appeared well maintained. The action and barrel were largely free from signs of corrosion and showed wear commensurate with normal use. The barrel was not that originally fitted to this firearm and I understand that it had been replaced sometime circa 1950. The stock also showed signs of alteration from its original condition. The brown-
